Engineering Services  
Instrumentation Monitoring  
Report for the Arecibo Municipal Solid Waste Landfill

Prepared by GEO-Engineering Services, Inc.  
Under Contract No. G-100-17-0001, dated March 16, 2018.

Re: Instrumentation Monitoring for  
Municipal Solid Waste Landfill  
Arecibo, Puerto Rico  
(GEO-853-2014)

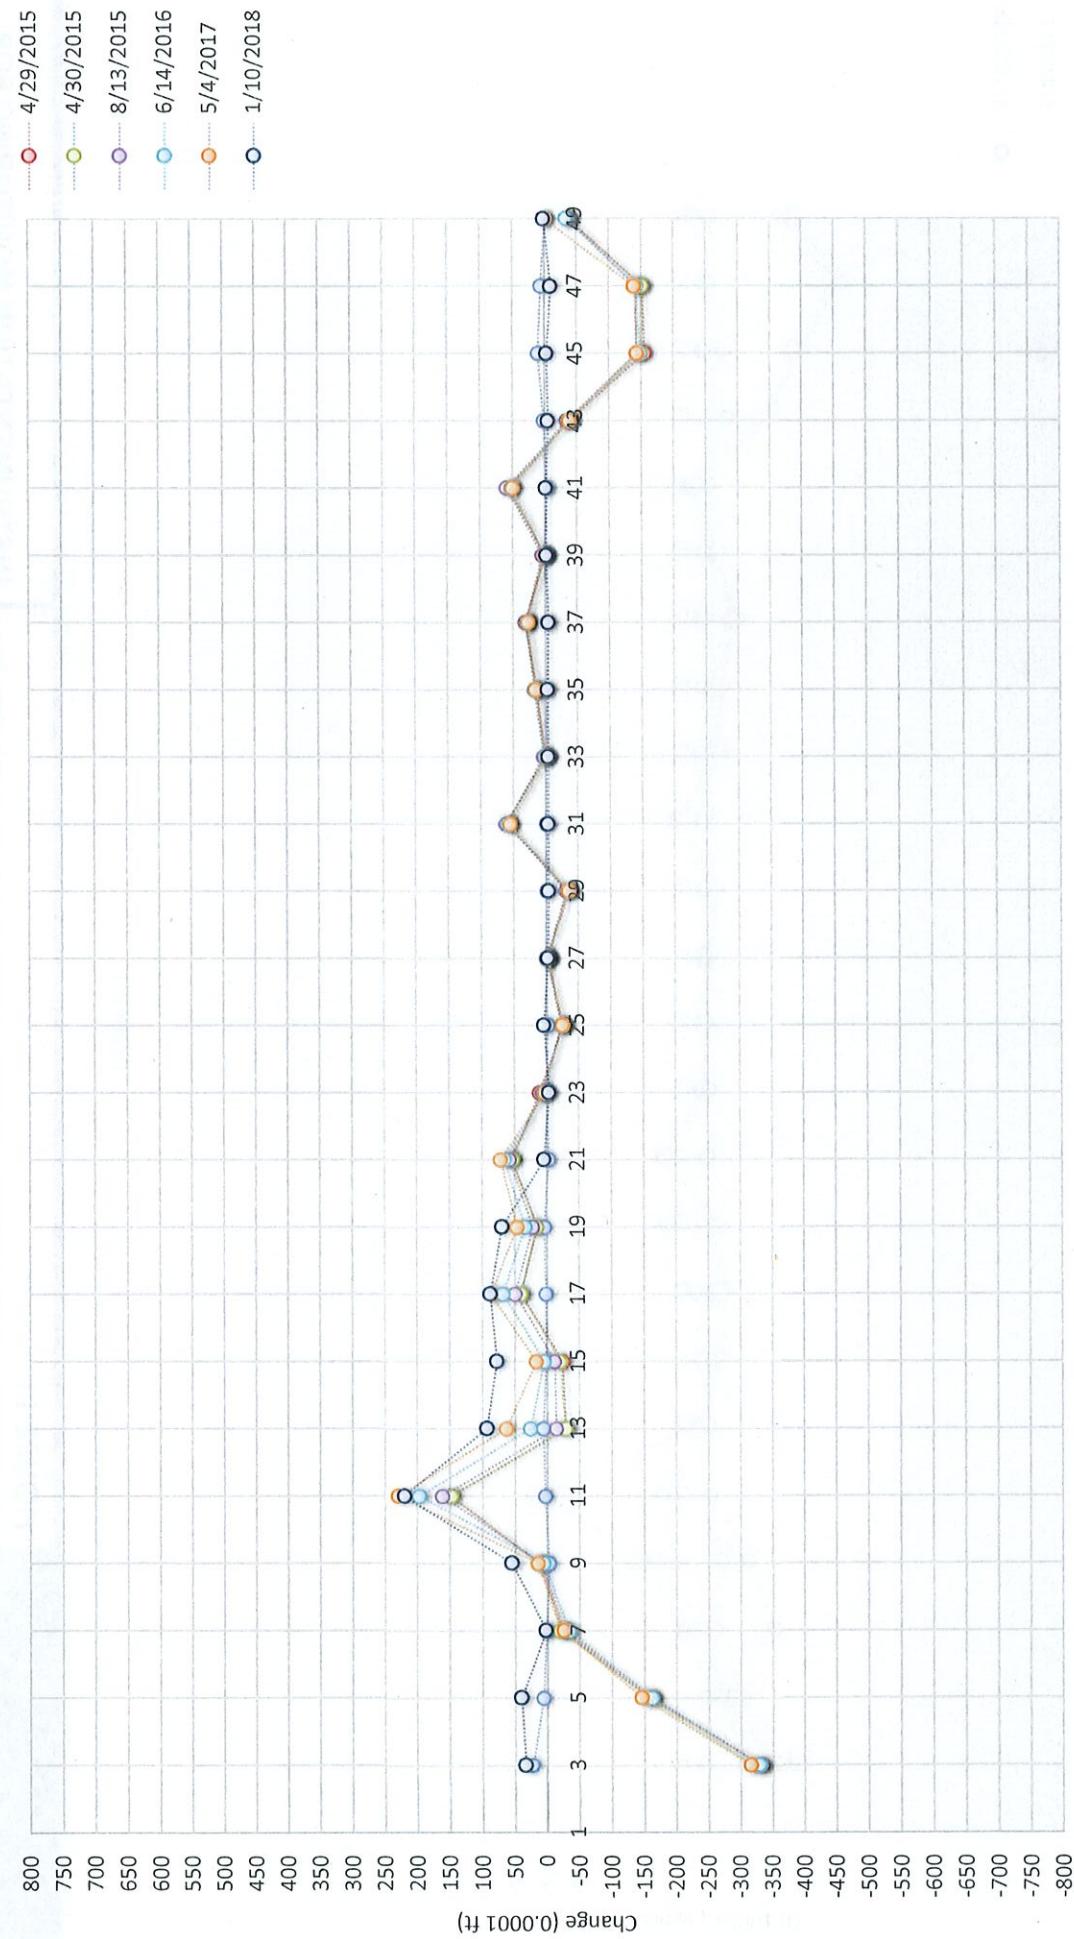
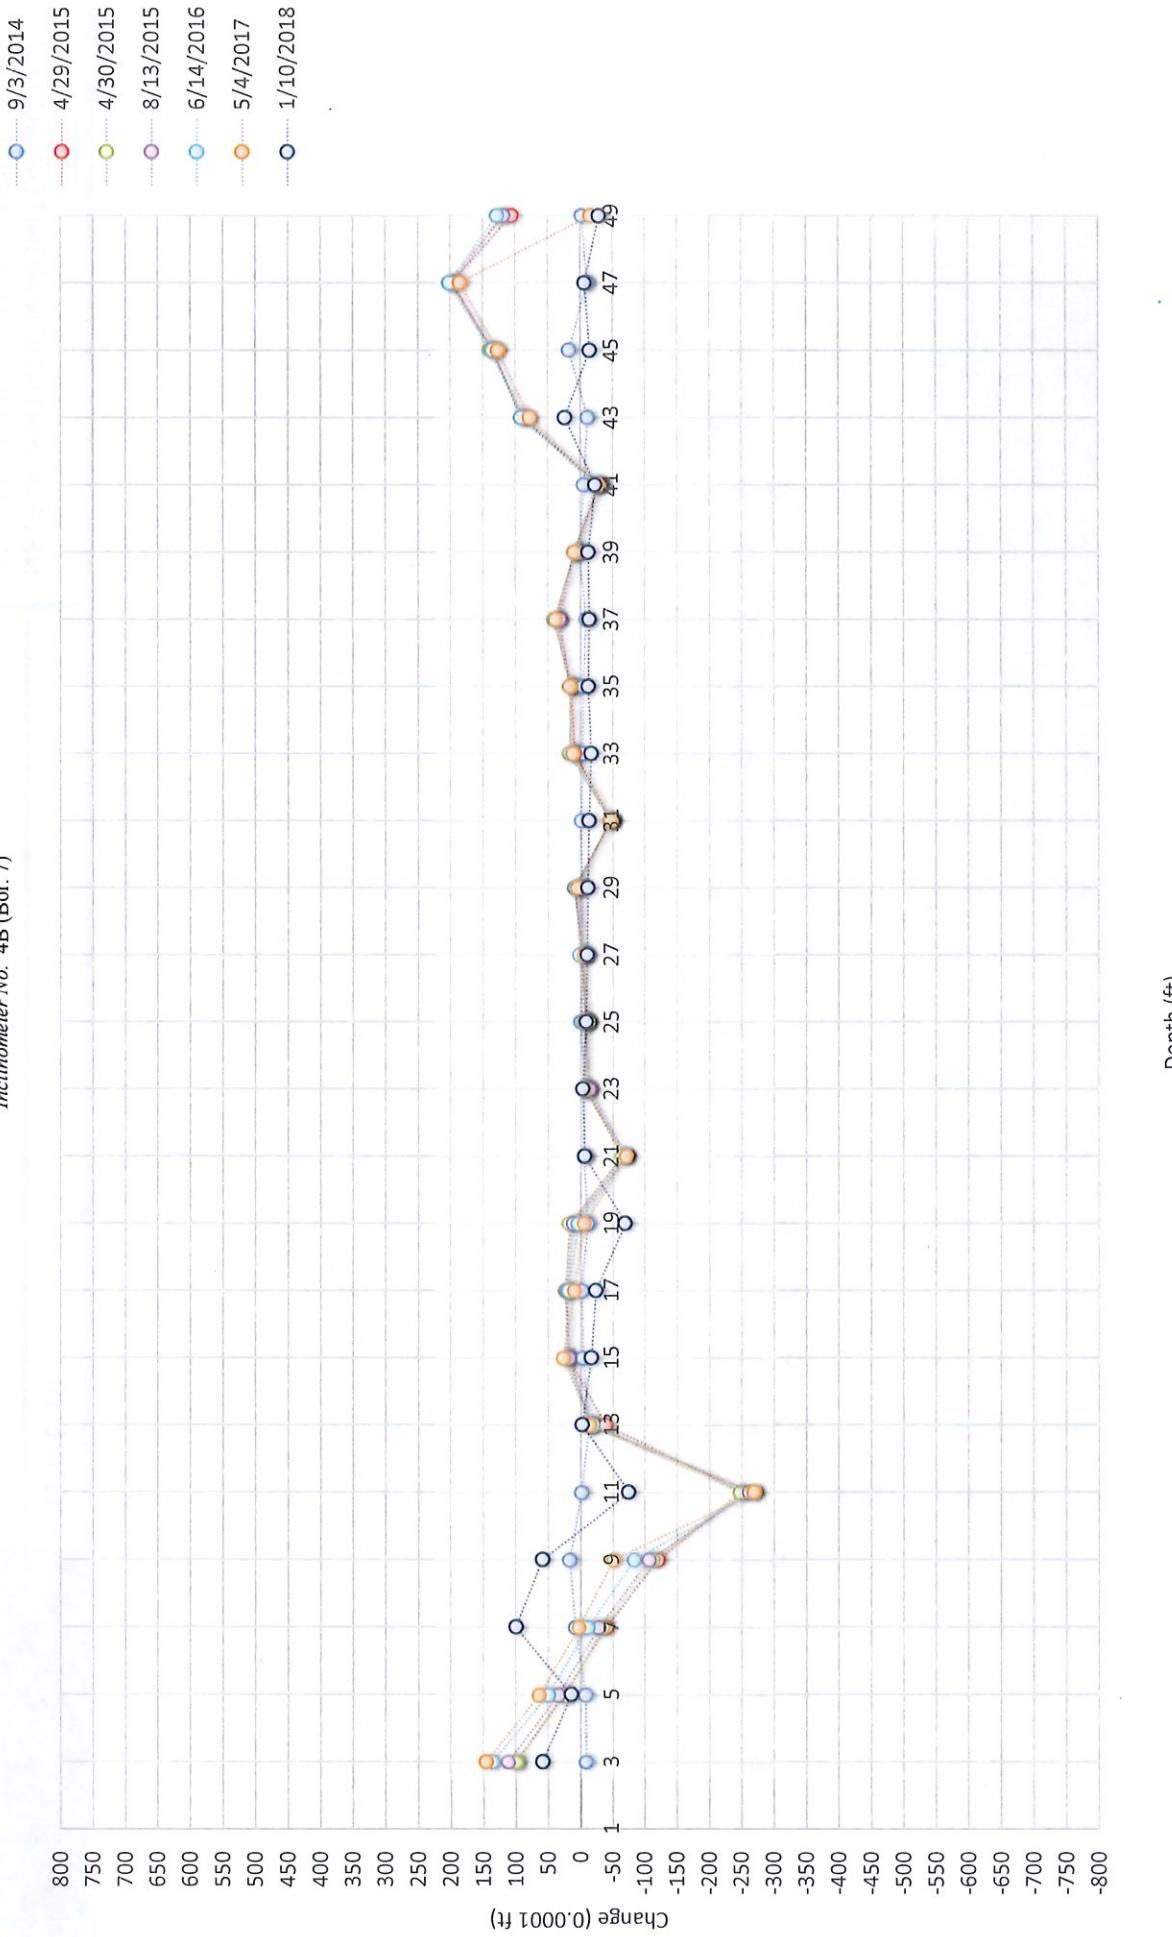
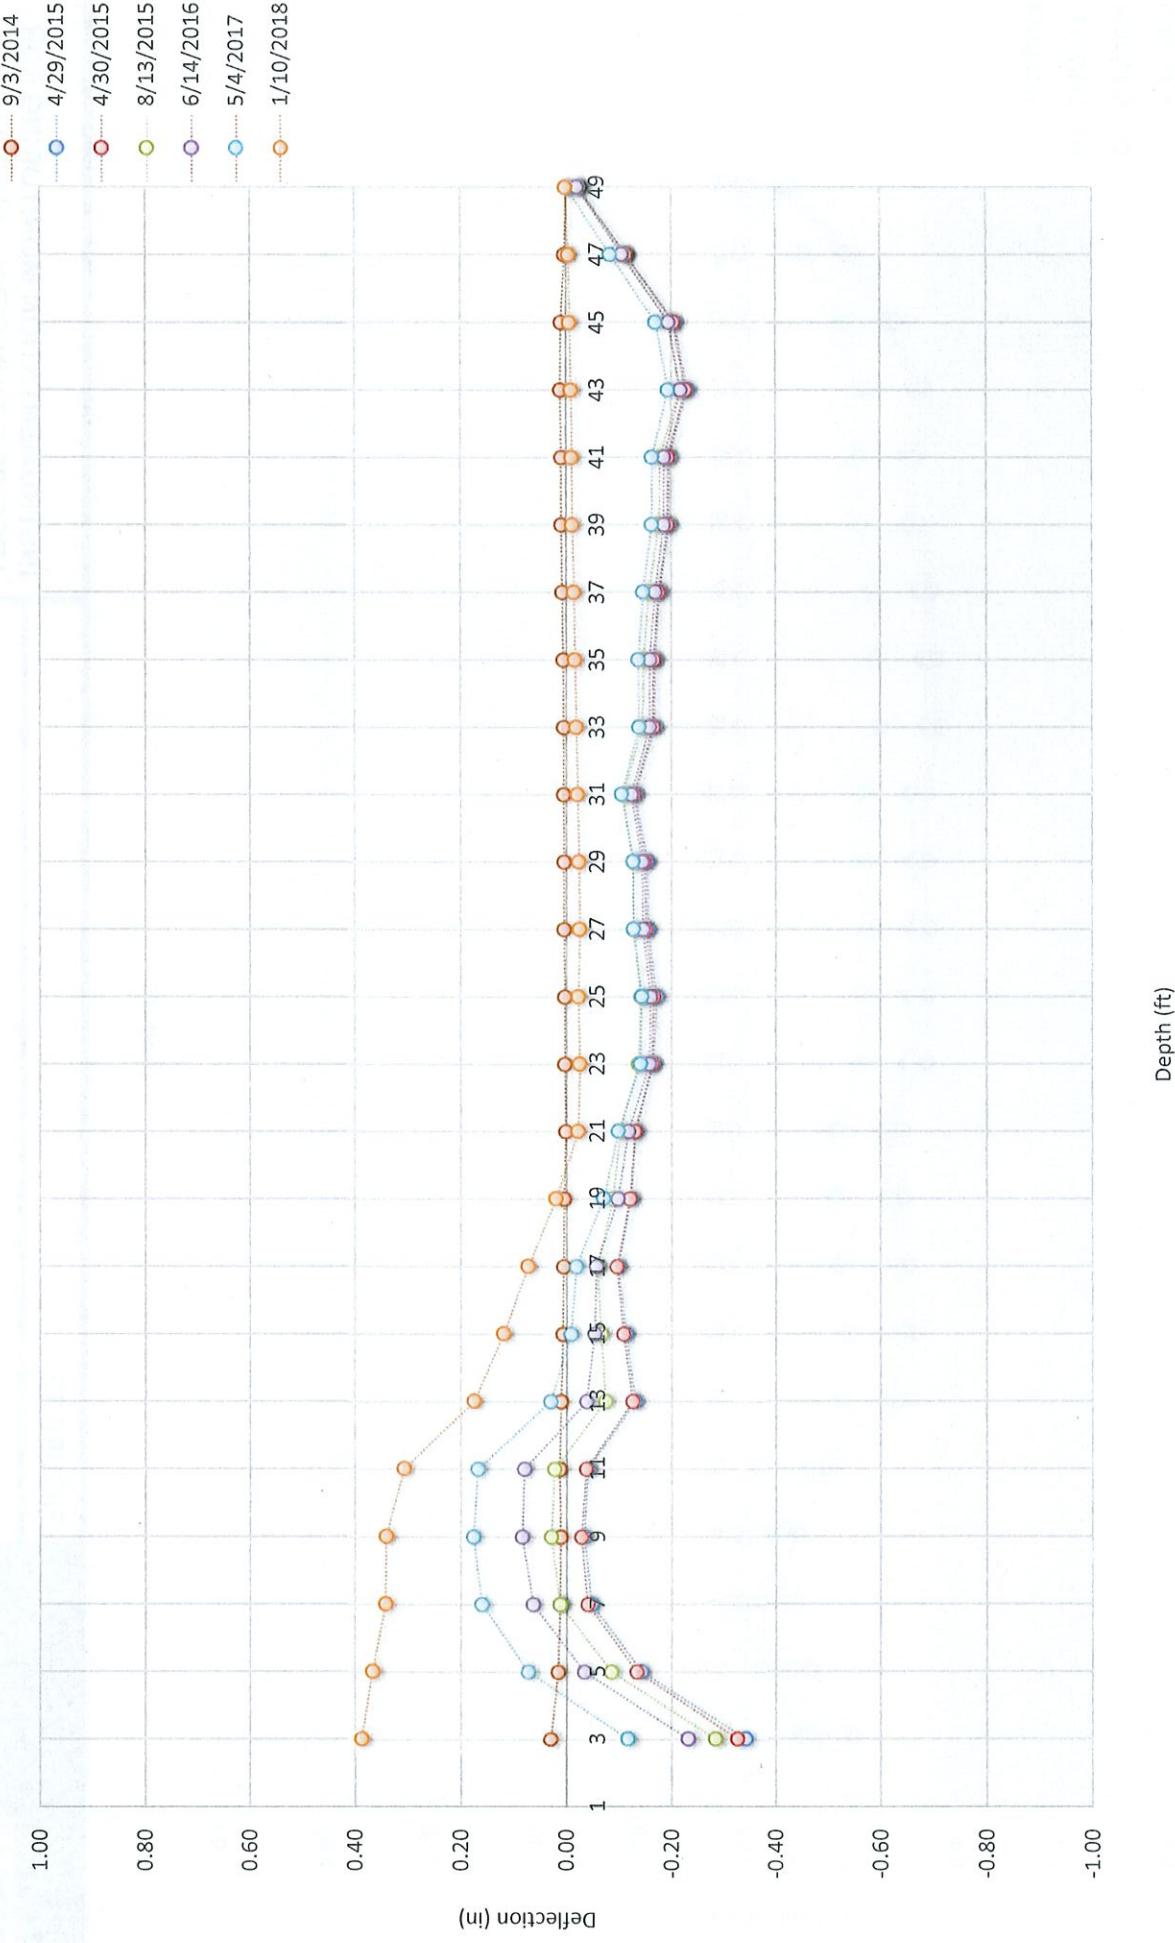
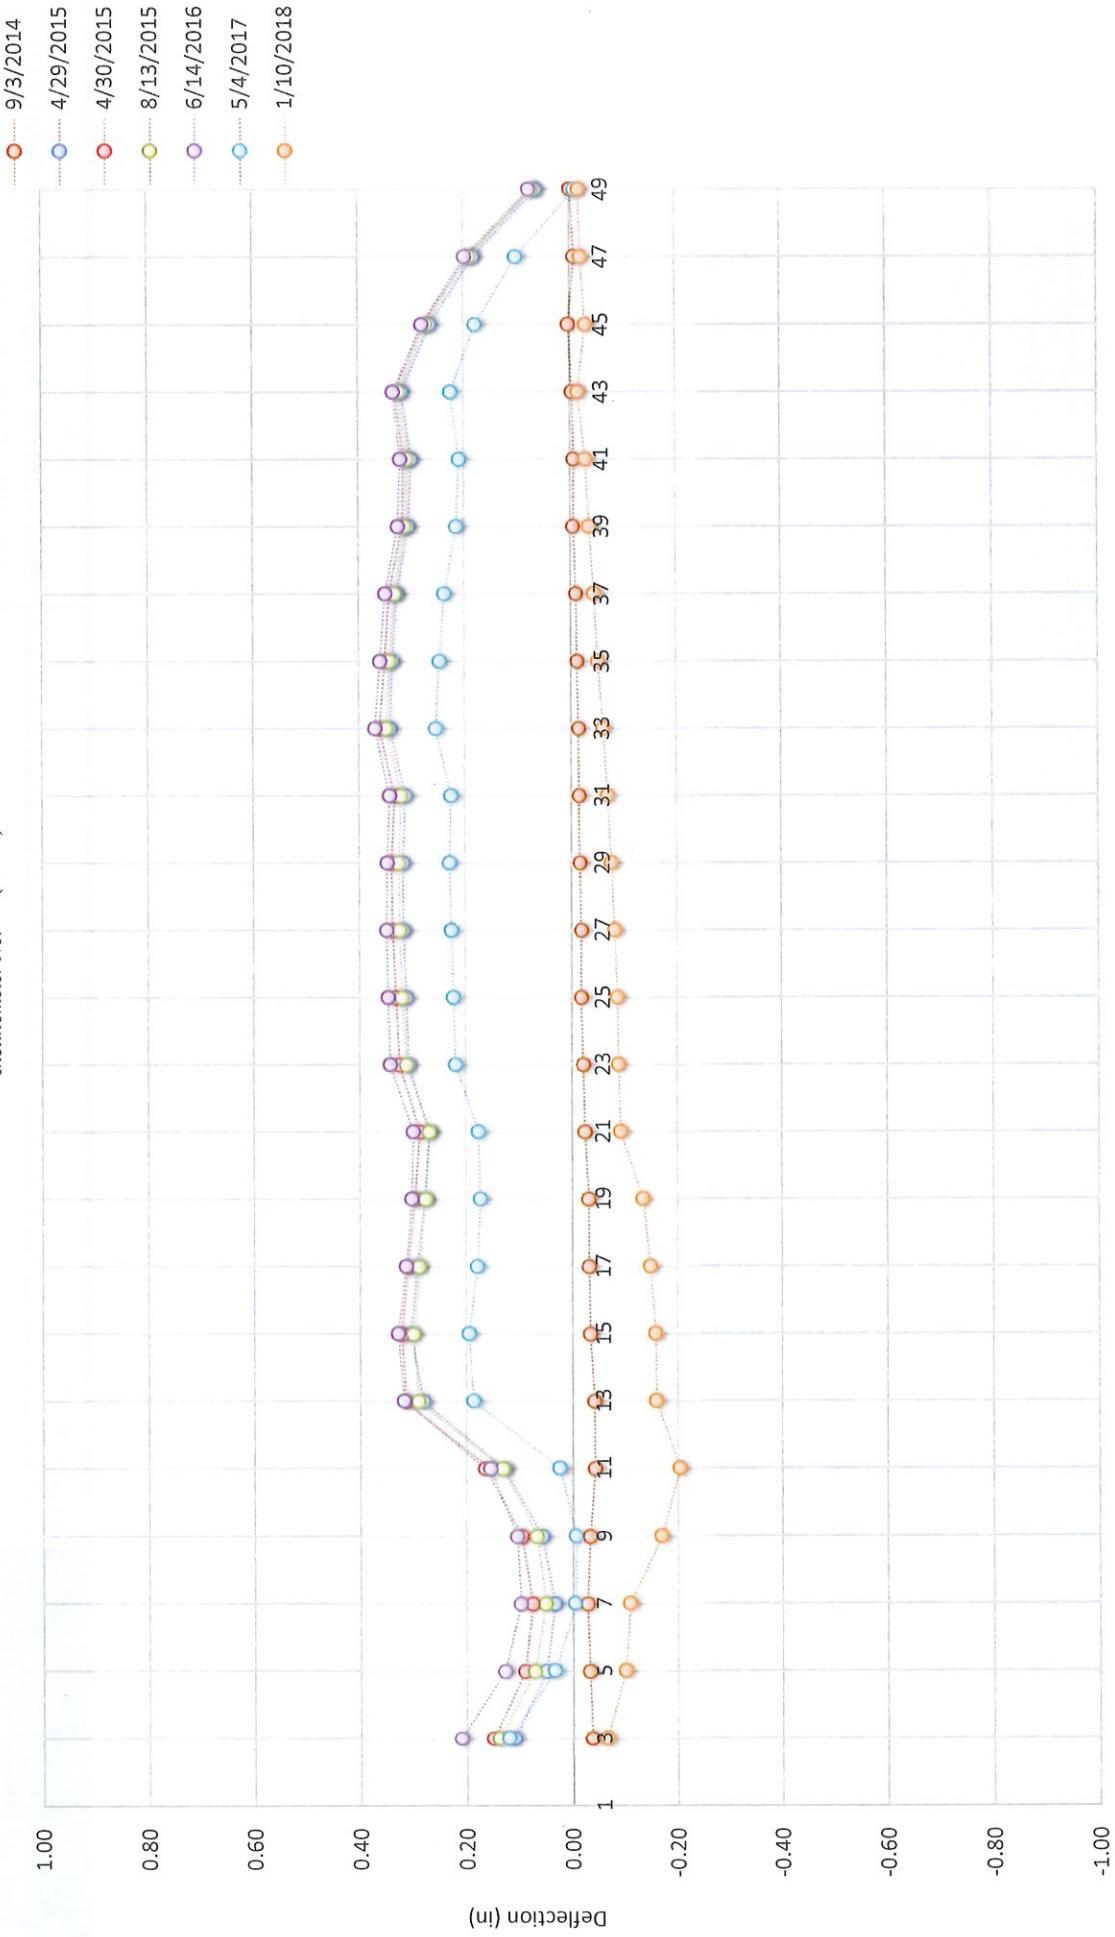
- The reading from inclinometer I-4 shows a downslope deformation at a depth between 11 ft and 15 ft, near the contact between the existing upper fill and underlying solid waste. However, when compared with the previous reading of May 2017, the maximum casing deformation is practically the same. The detected deformation is probably due to buckling of the inclinometer casing caused by vertical and/or lateral deformations developed within the fill and/or solid waste. The maximum deflection reached by the inclinometer casing in close to four years of monitoring is of approximately 0.30 inches. No cracks were observed at the ground surface that would indicate that large lateral movements were occurring within the ground.

Previous readings of inclinometer I-4 showed an upslope deformation at a depth of 3 ft. The reading from January 10, 2018 showed that the upslope deformation had apparently halted. Additional readings will be required to confirm if the lateral deformations at this depth have stopped.
